Portage Creek Sediment Remediation Project Kalamazoo, Michigan

Pre-Sediment Removal Structure Feature Assessment
Removal Areas SA1-A, SA1-B and SA1-C

F&V Project Number: 809930
May, 2013

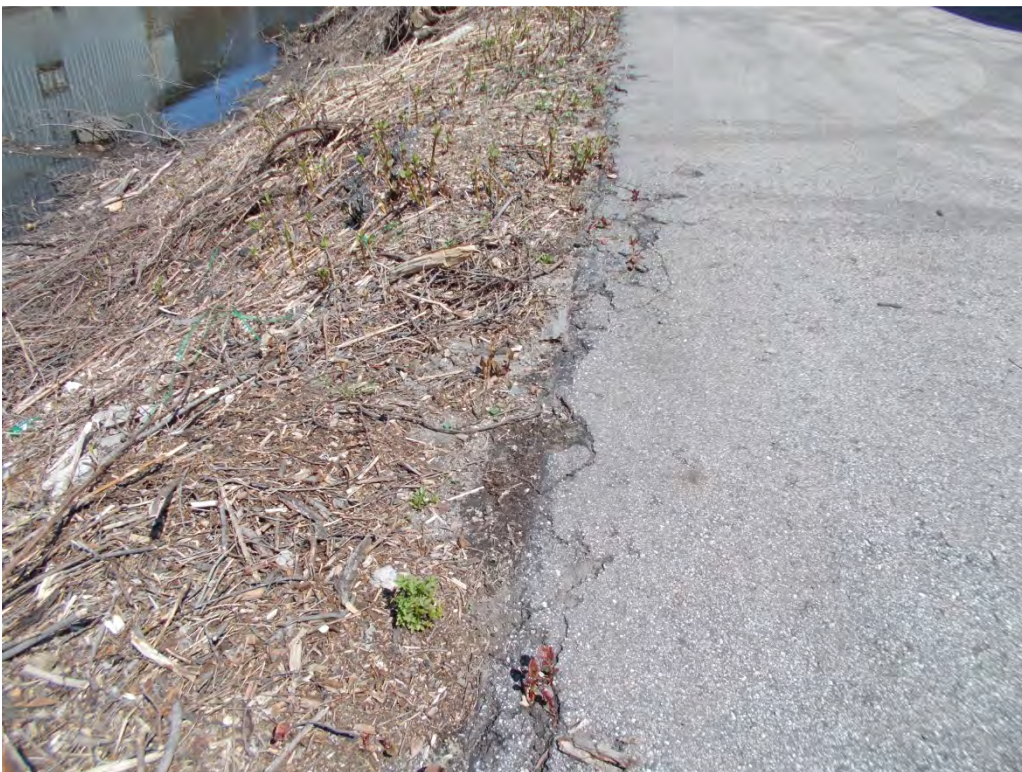
Edge cracking and spalling

- Repair or replace damaged areas of pavement as required.

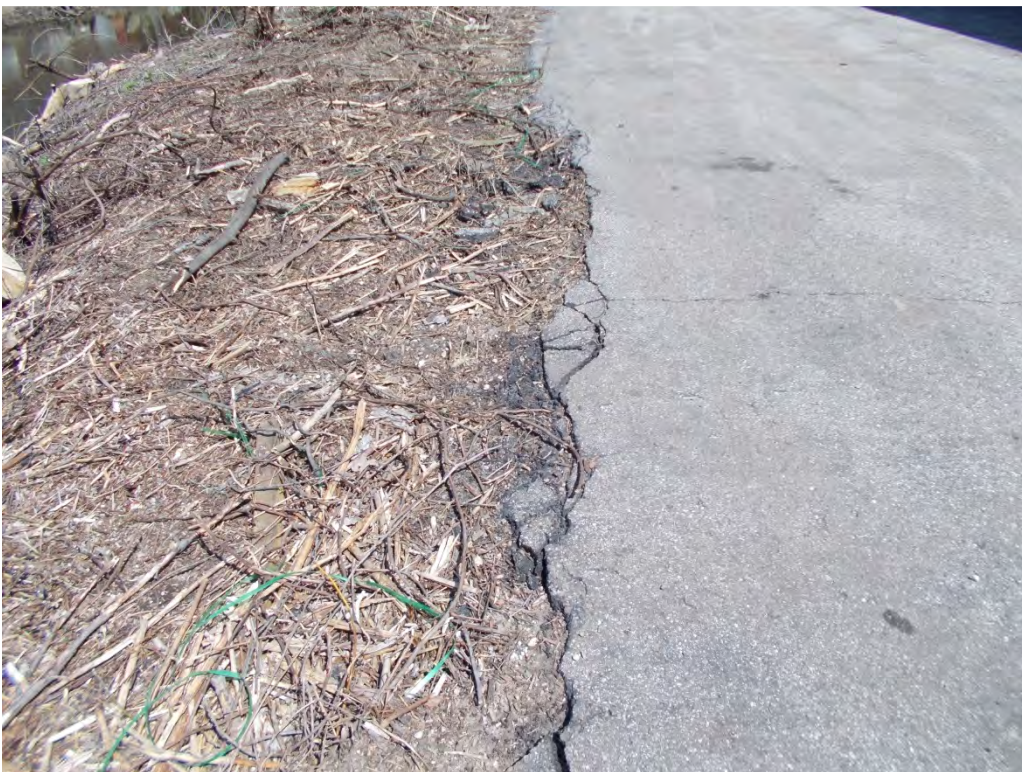
Severe edge cracking and spalling

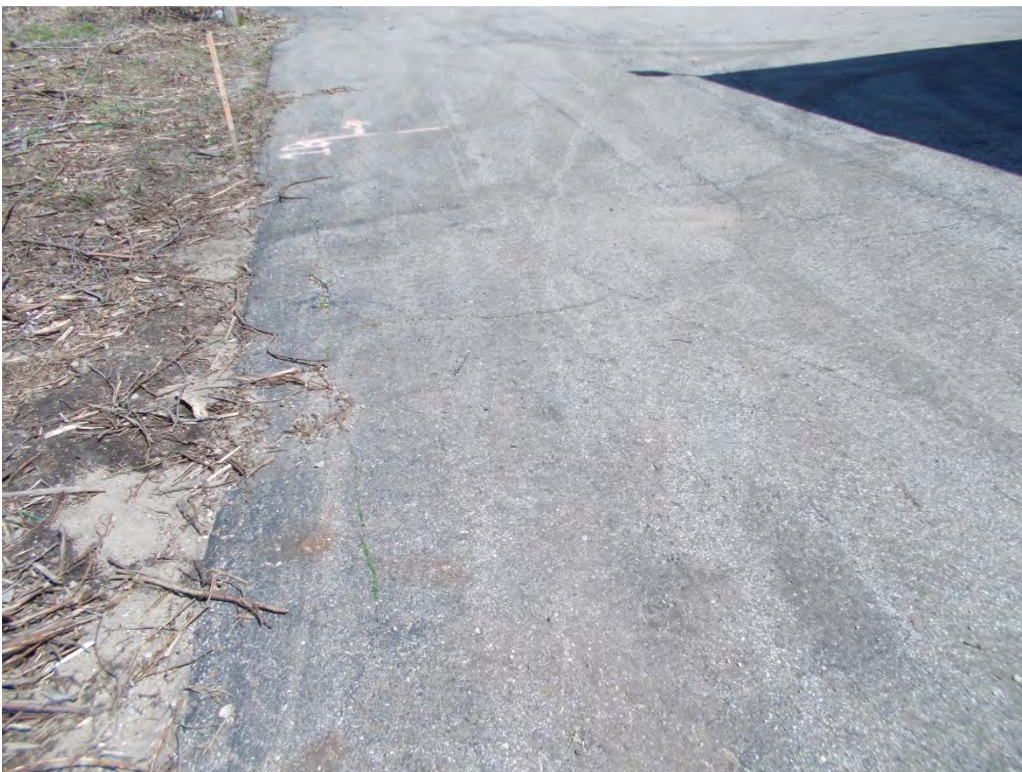
Random cracking in pavement

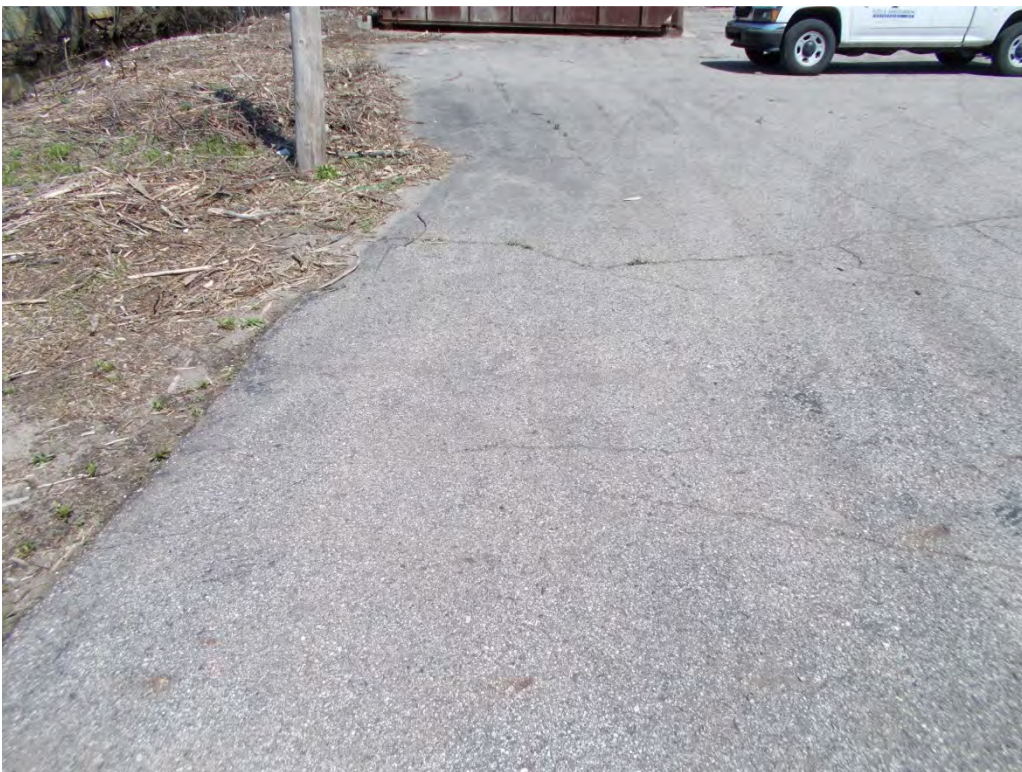
Random cracking in pavement

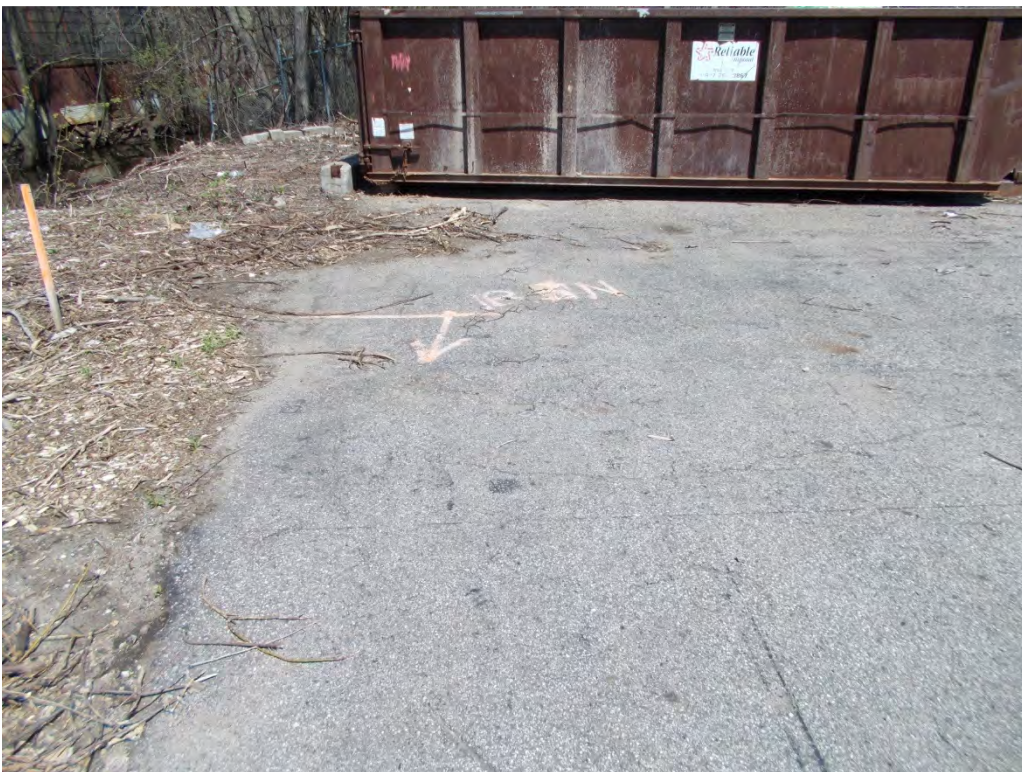
Pavement at north end of SA1-B

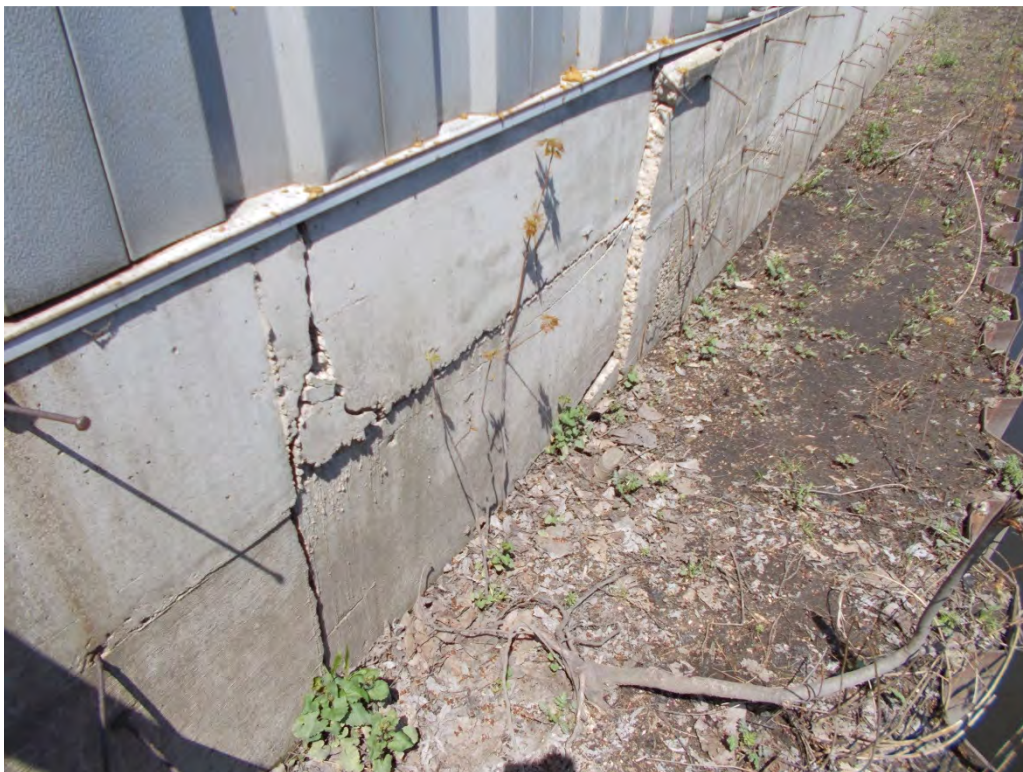
- The channel is 3.5-4.0 feet below the top of sheet pile.
- The concrete foundation wall has moderate honeycombing at pour joints. There is an area of critical vertical cracking with a 2" offset in the wall near the change in roof lines. There is a moderate vertical crack near the north end of the sheet pile.

Area of critical cracking in concrete foundation wall

- Due to the limited sediment removal depth (approximately 1 foot), it should be possible to remove sediment against the sheet pile wall without disturbing it.
- It is recommended that the bank north of the sheet pile wall be left intact to avoid impacting the unknown foundation for the northern section of the building. If the bank cannot be left in place, a longitudinal cofferdam is recommended along the building with a minimum clearance of approximately 4 feet.
- Avoid excavation within 3-4 feet of the exposed concrete footing to prevent undermining or other disturbance.

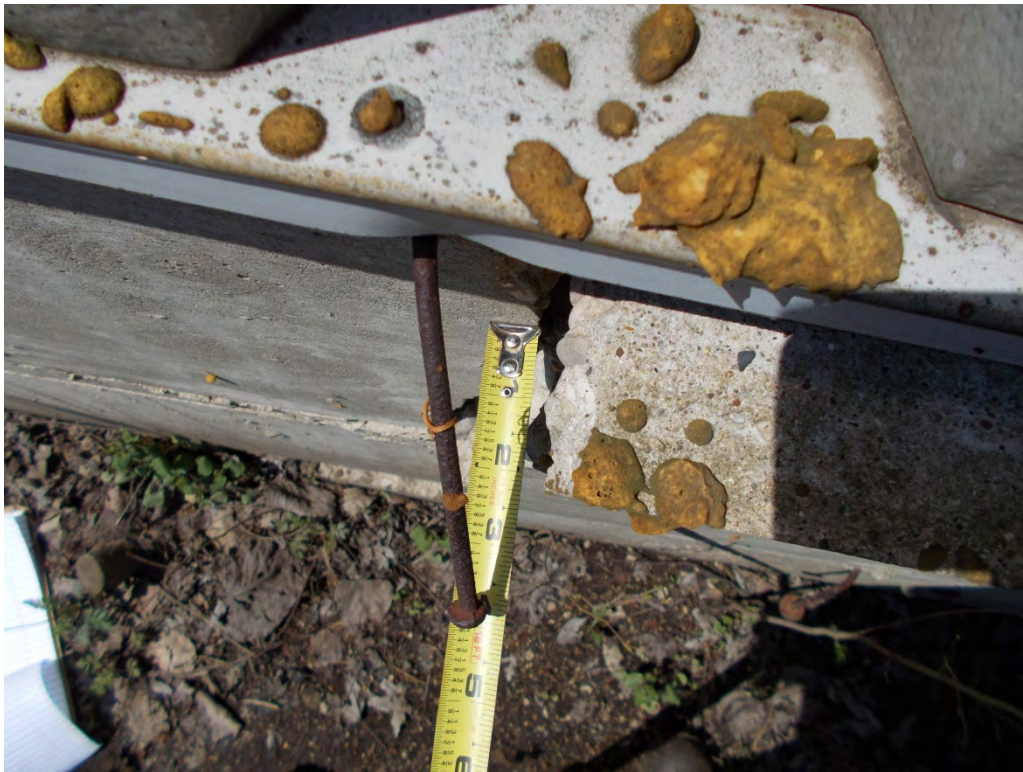
View of offset at critical cracking looking down

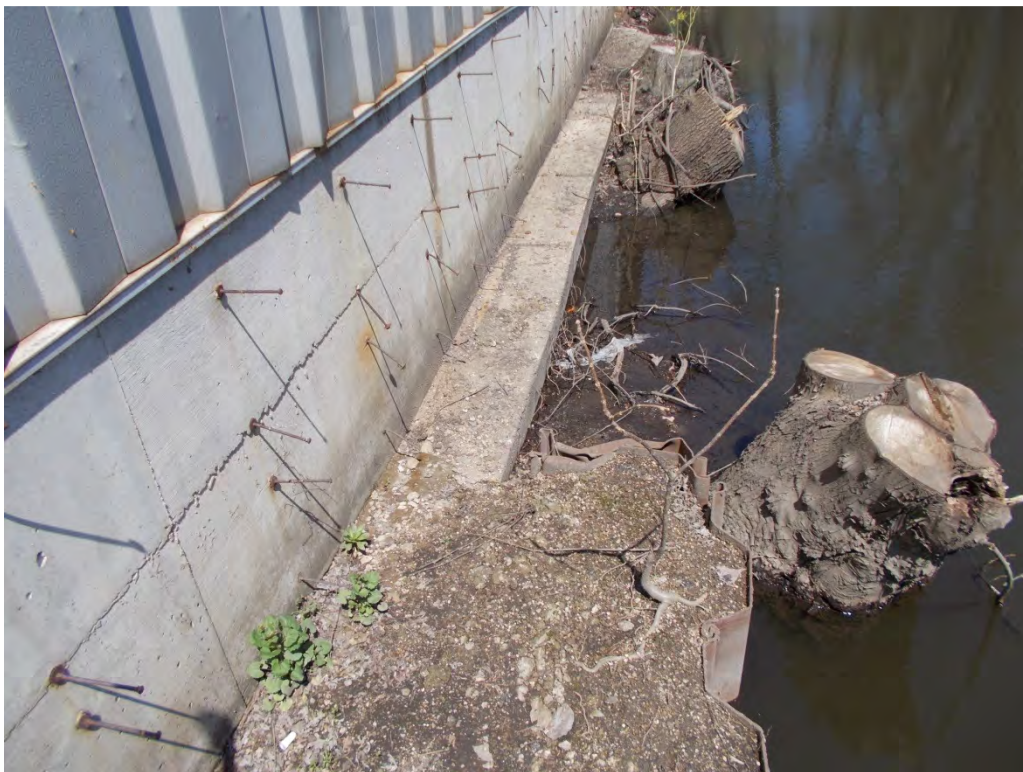
- The bank north of the sheet pile is mostly intact due to a series of large trees and stumps. The footing of the northern end of the concrete foundation wall is exposed approximately 8-12 inches.

Exposed footing at north end of southern section of building

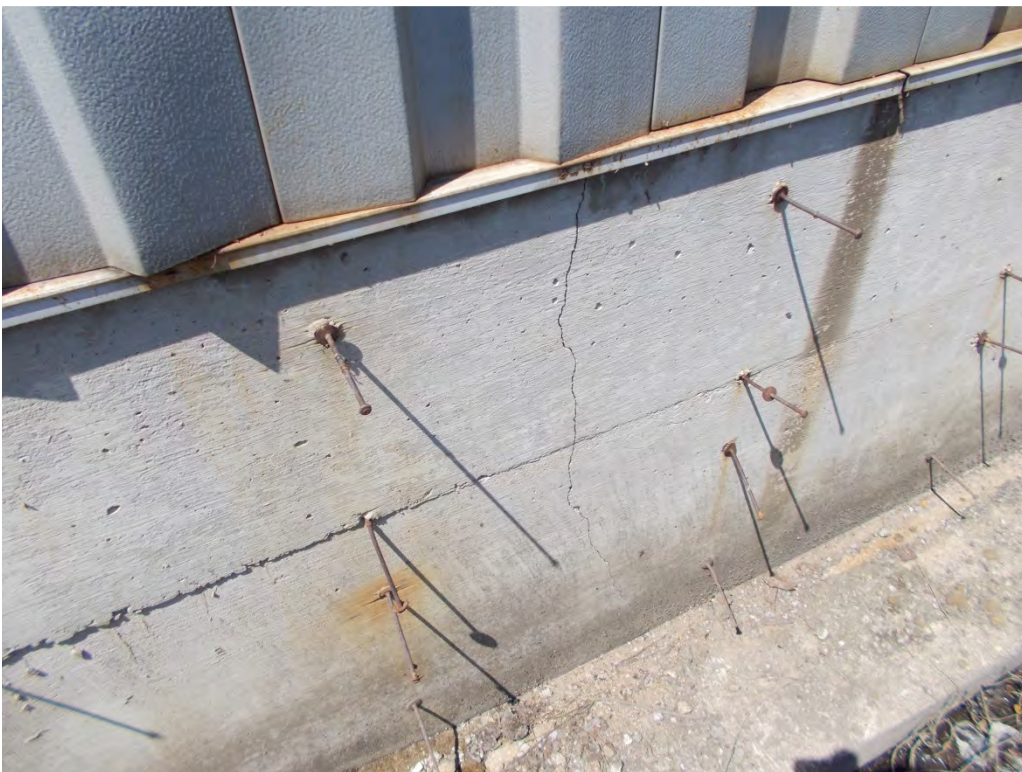
Moderate vertical cracking near north end of sheet pile

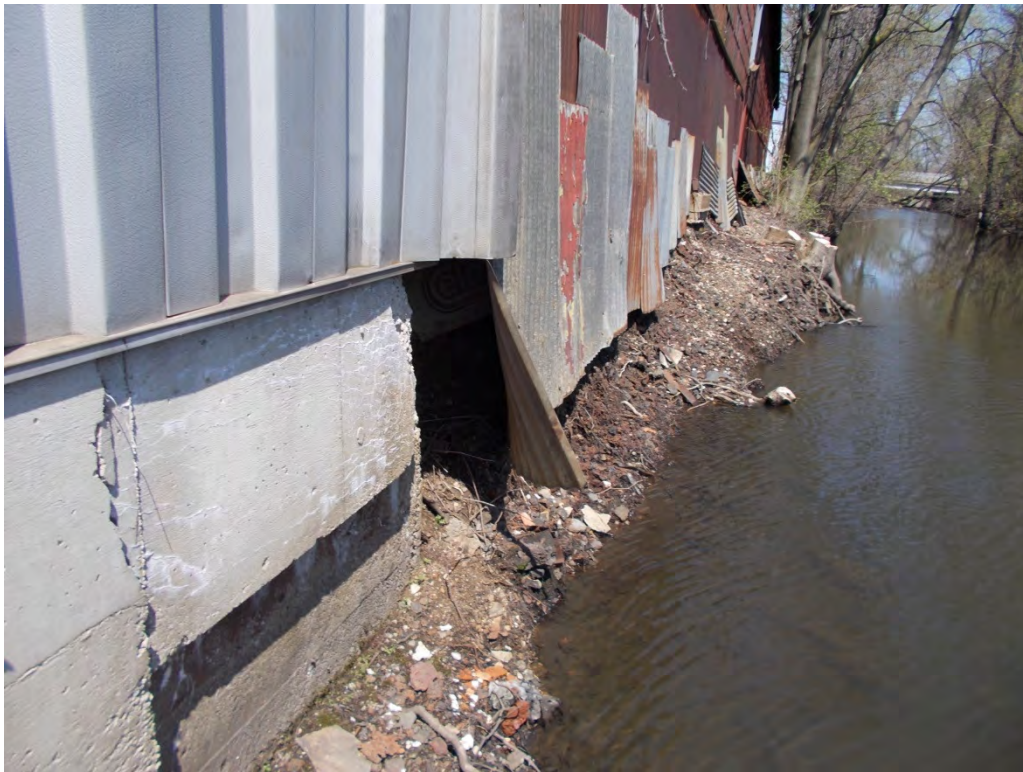
- The siding on the southern portion is buckled and damaged throughout.
- The corrugated siding on the northern section has moderate to severe surface corrosion. It is bent back near the transition between sections and generally in poor condition.

Bent corrugated siding at building transition

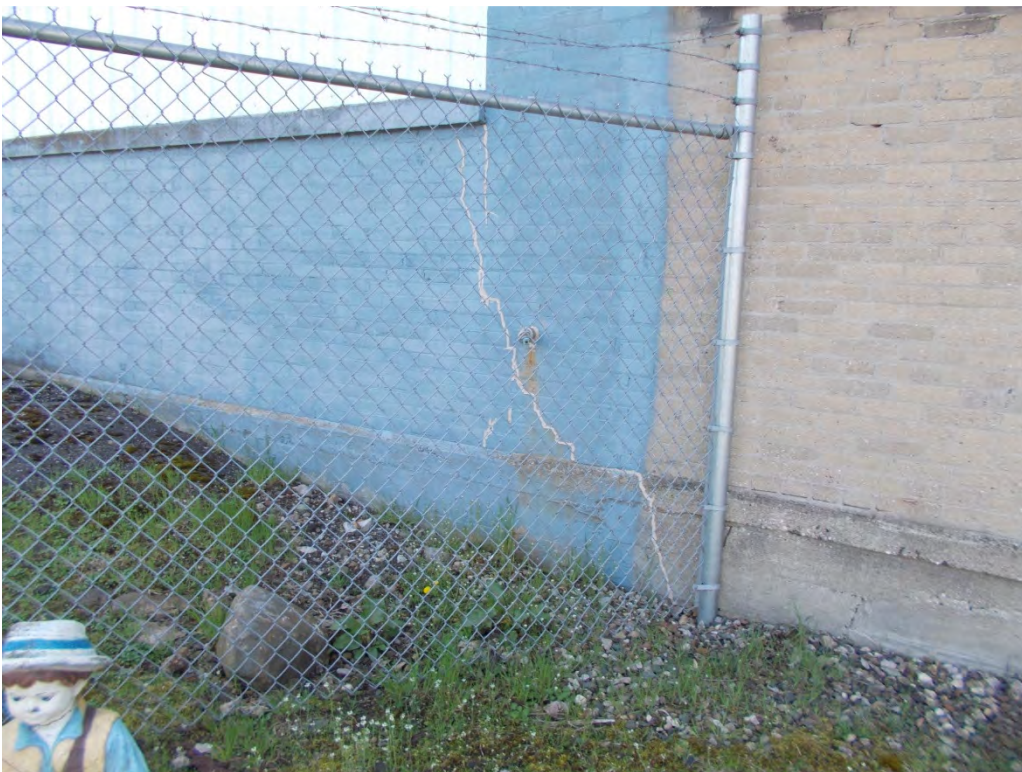
Sealed step/diagonal cracking in brick wall

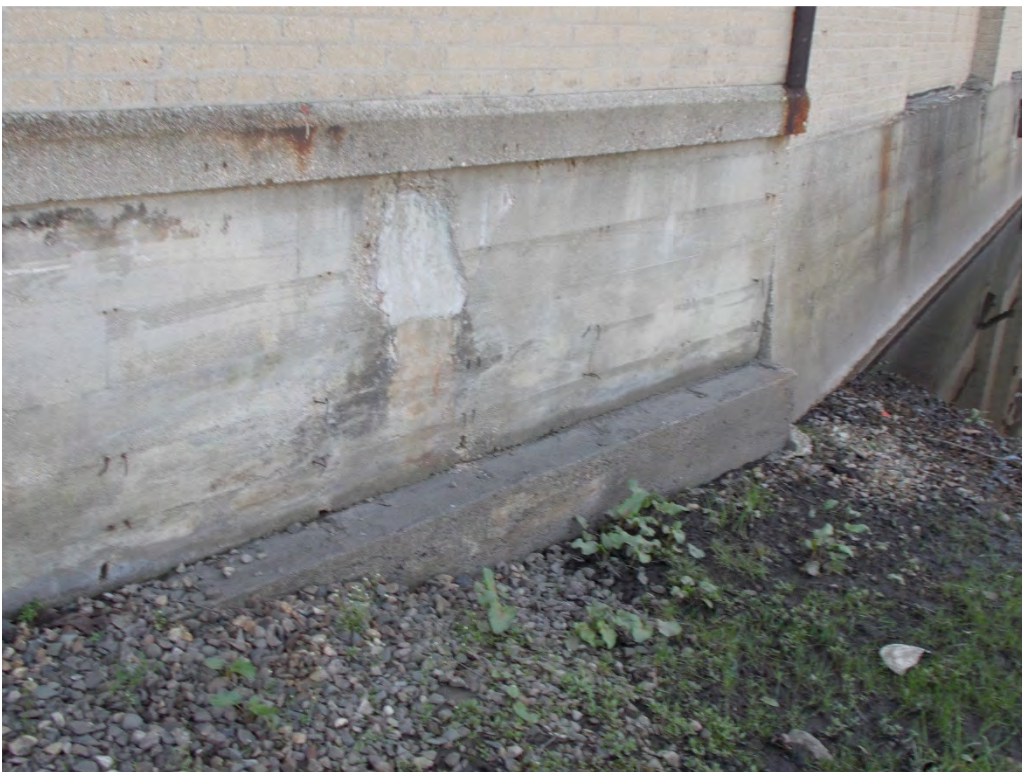
- Minor cracking, severe honeycombing and exposed form ties were noted in the concrete foundation wall.
- The footing is exposed upstream of SA1-C. Minor undermining was noted at the building transition.
- Moderate vertical and step cracking were noted in the brick. Cracking was noted in the primary wall and originating at window penetrations.
- A minor horizontal crack was noted between the concrete foundation and brick near the building transition.
- The eastern section of the building has sealed diagonal/step cracking near the fence line.
- Consumers Energy mapping shows a 2" gas crossing Portage Creek, however it appears to be west of SA1-C-S01 and outside the cofferdam limits.
- City of Kalamazoo mapping shows a water main crossing Portage Creek, however it appears to be west of SA1-C-S01 and outside the cofferdam limits.

Exposed footing near building transition

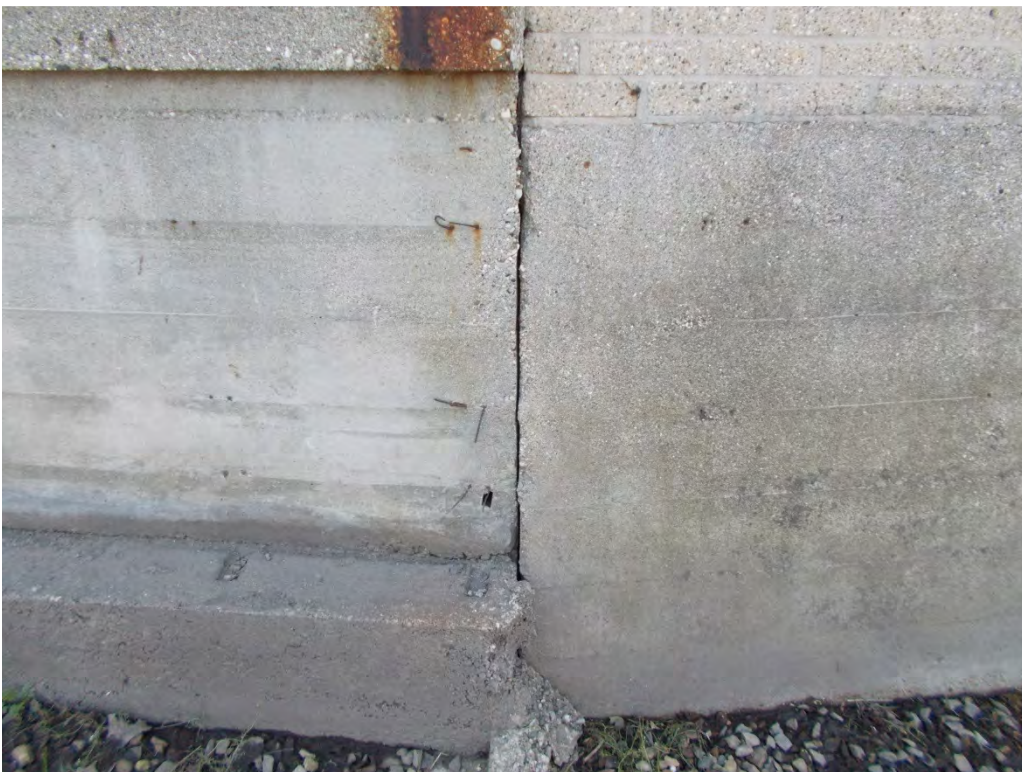
Joint separation at building transition

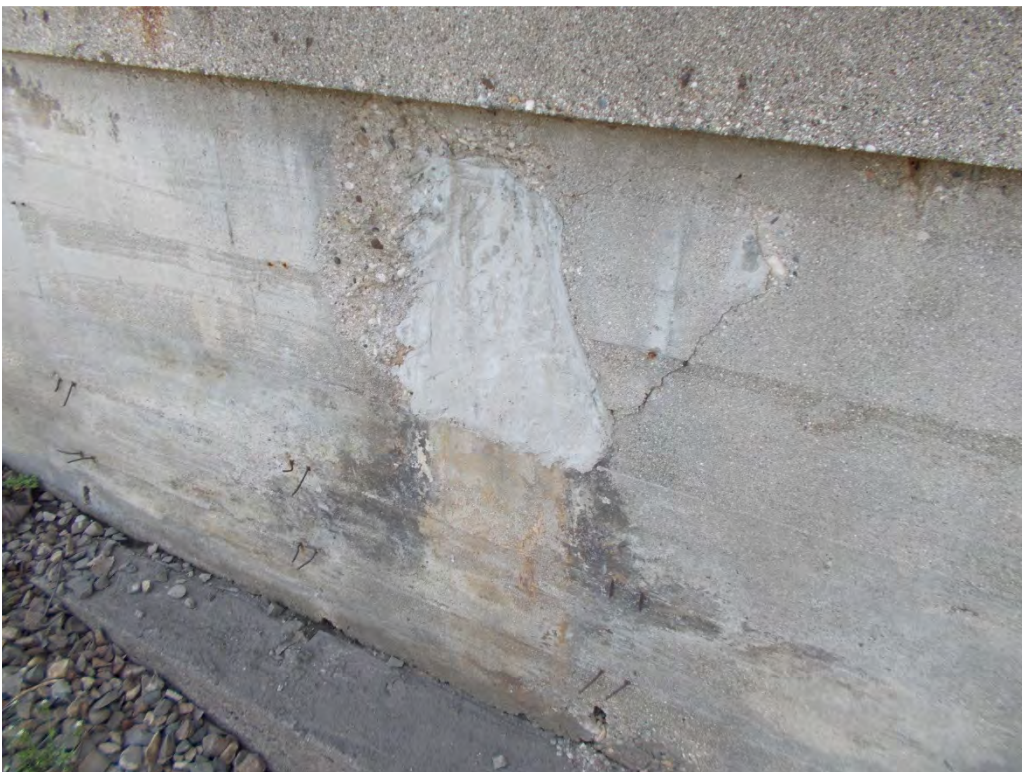
Cracking and patched spalling on face of foundation wall

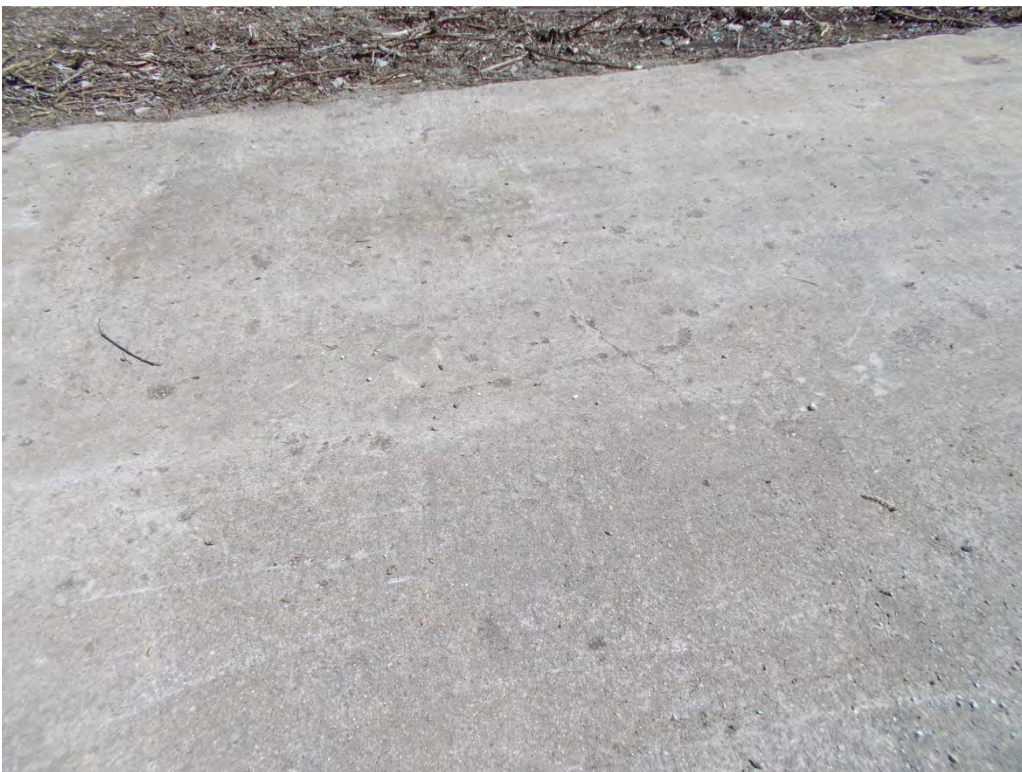
- The pavement appears to be abandoned. It is in fair condition with scattered minor to moderate cracking.
- The top of bank is eroded along the channel side of the pavement.
- There is a 2-3" void in the interior area of the pavement.
- A stone access road has been constructed around the pavement.

Cracking in surface of pavement

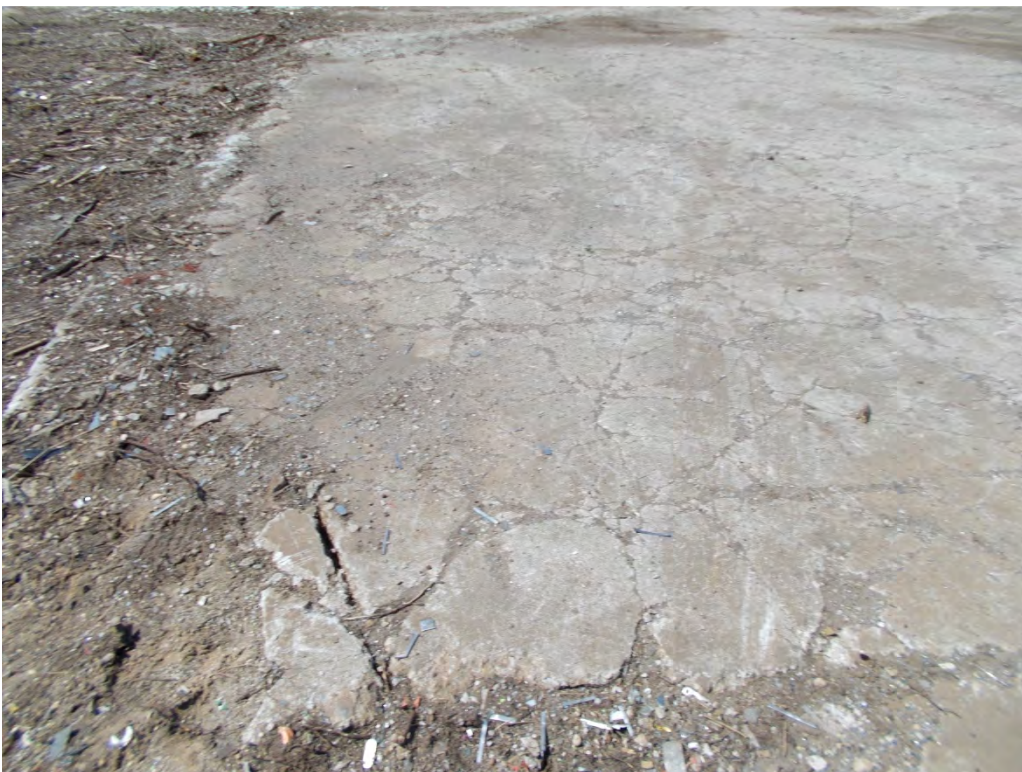
- The pavement is in critical to failed condition with alligator cracking and spalling throughout.

Severe cracking and spalling of pavement

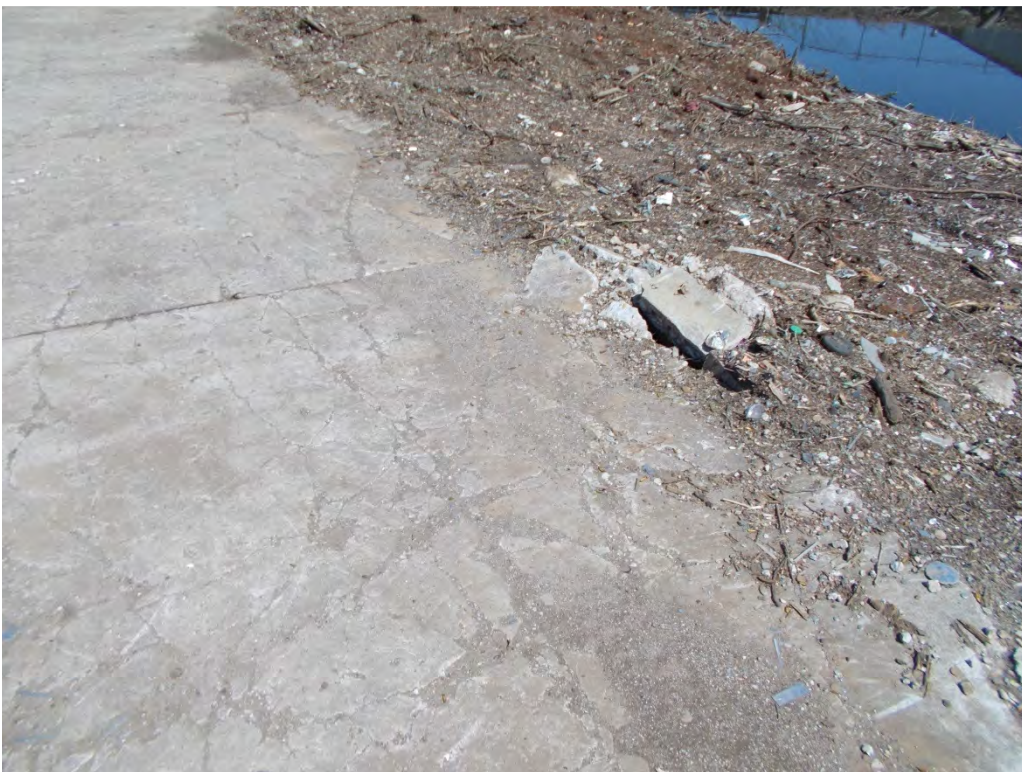
Severe cracking and spalling of pavement

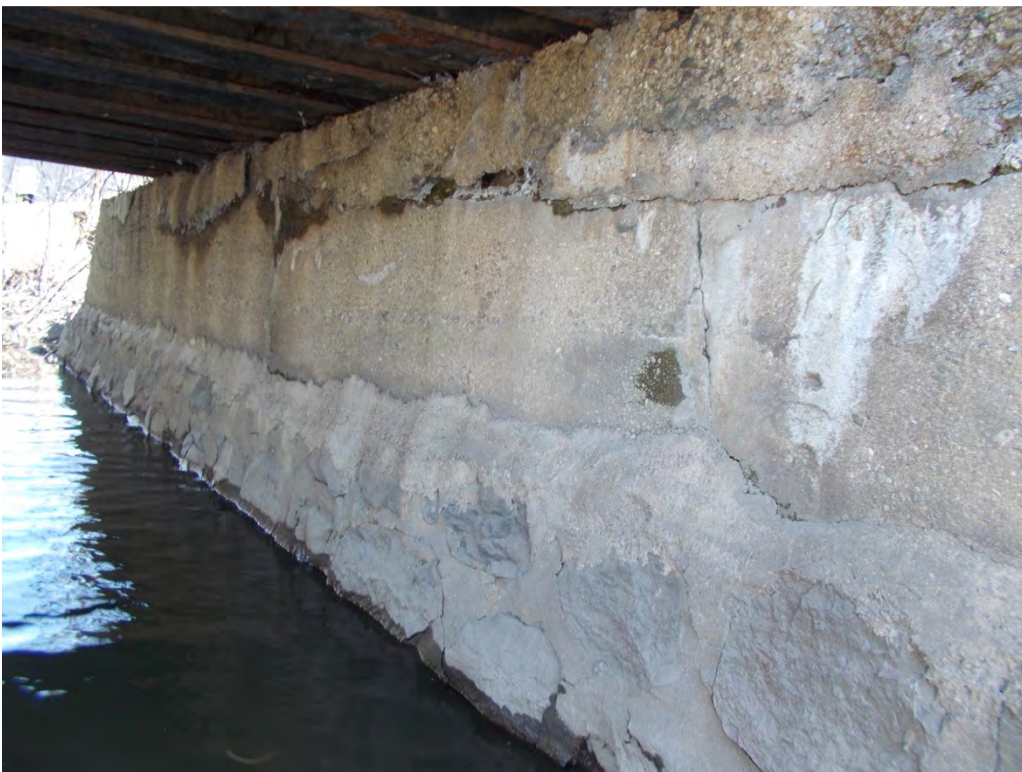
- The upper concrete abutments have moderate weathering. The lower stone abutments have grout voids, many of which have been patched. No undermining was detected.
- The steel beams have minor to moderate surface corrosion.
- Timber ties have severe to critical rot and section loss.
- The timber railing has a failed top plate the entire east half of the structure.
- The structure carries two sets of steel tracks, as it is located near a switch.
- Heavy brush is encroaching on the structure.
- Moderate to severe slope/bank erosion was noted all 4 quadrants. The channel spans abutment to abutment with no bank in place at the structure.

Patching on stone foundation

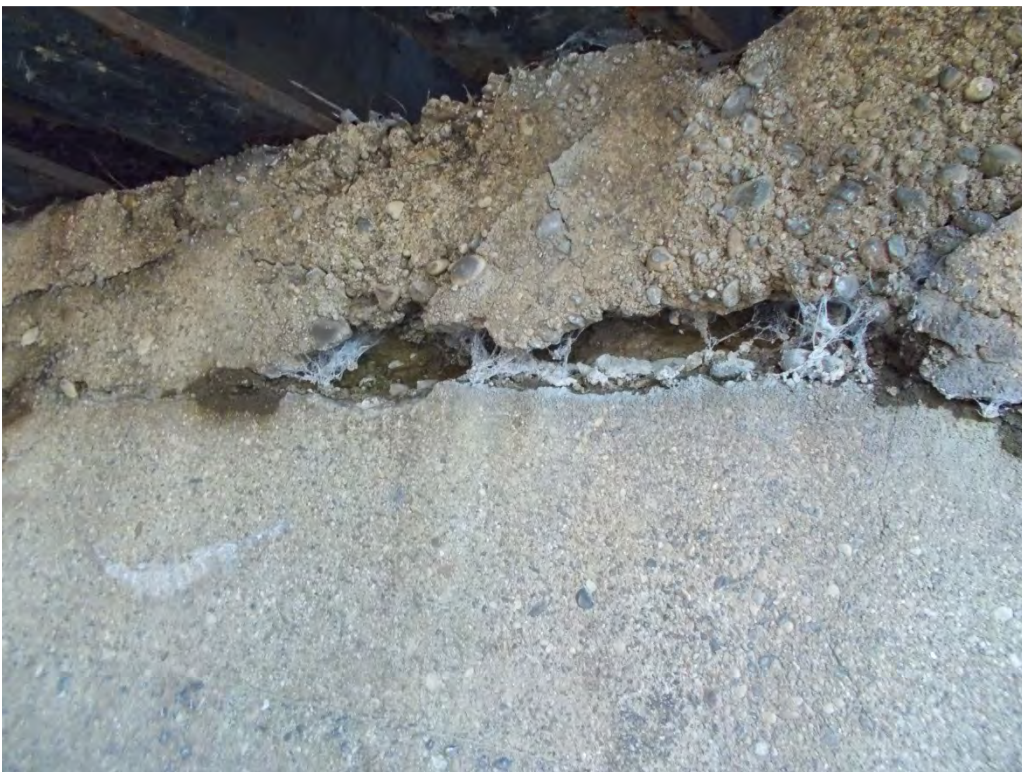
Deterioration of concrete abutment in bearing area

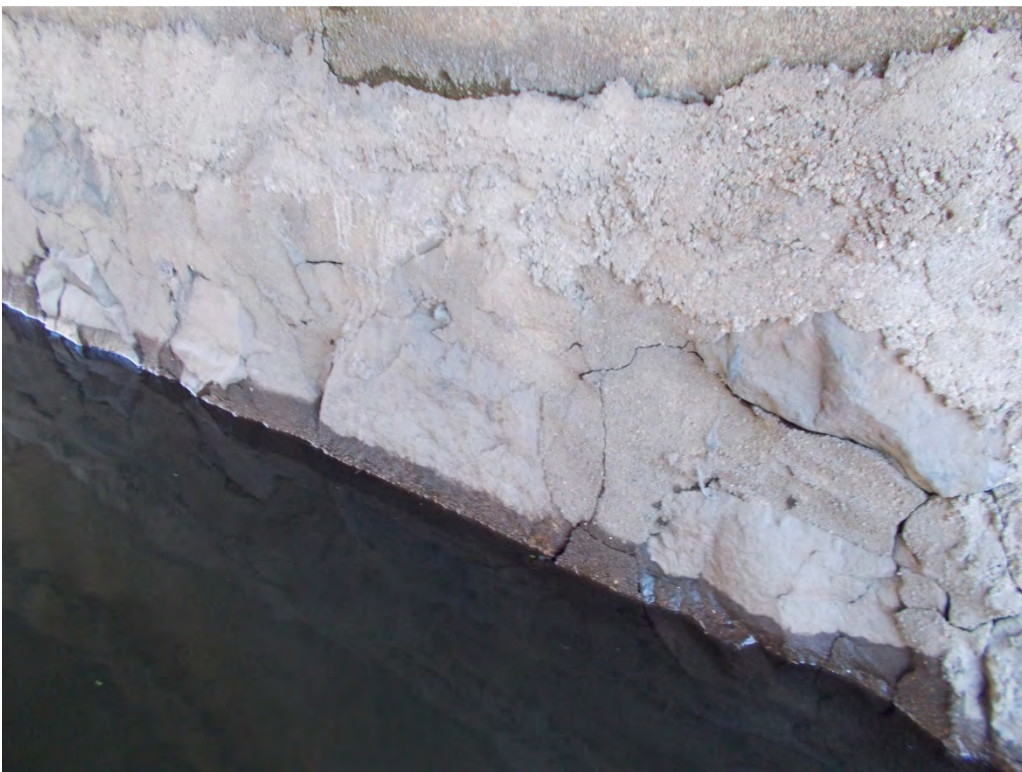
Patching on stone foundation
